38478 Cedar Boulevard,
Newark, CA

Tree Inventory and Assessment

June 21, 2022

Monarch Consulting Arborists

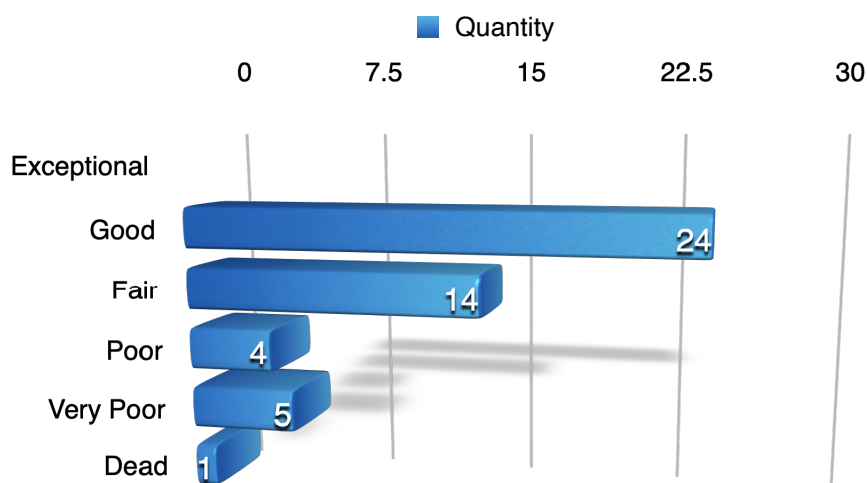
Chart 2: Condition Ratings

Twenty-four trees are in good condition, fourteen fair, four poor, five very poor, and one is dead (Chart 2). There are several trees in front of the "Public Storage" which have been topped and essentially destroyed including seven Canary Island pines.

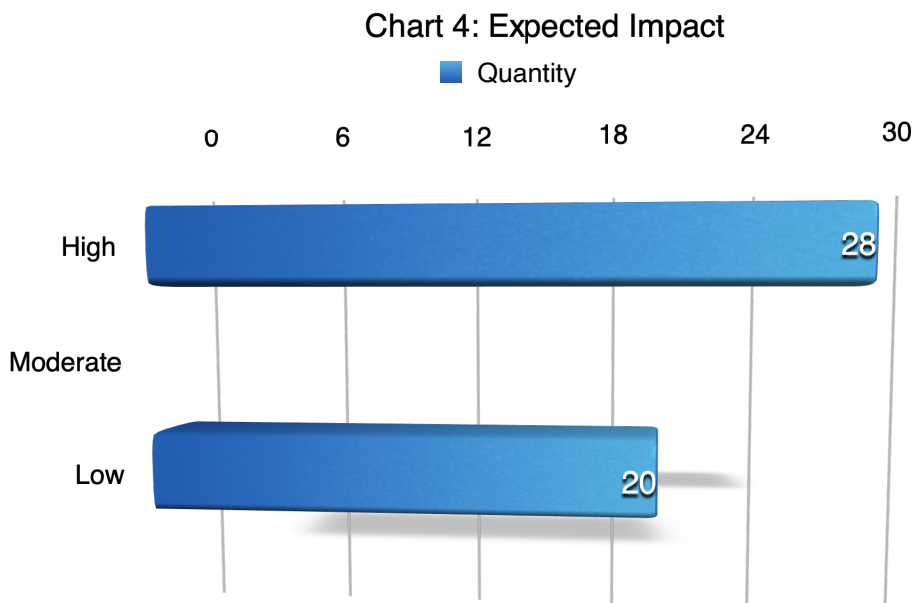
Twenty-eight trees will be highly impacted and caused to be removed while the remaining twenty are not expected to be impacted by the proposed improvements. At least seven trees on the “Public Storage” site are to be retained but should be removed due to condition.

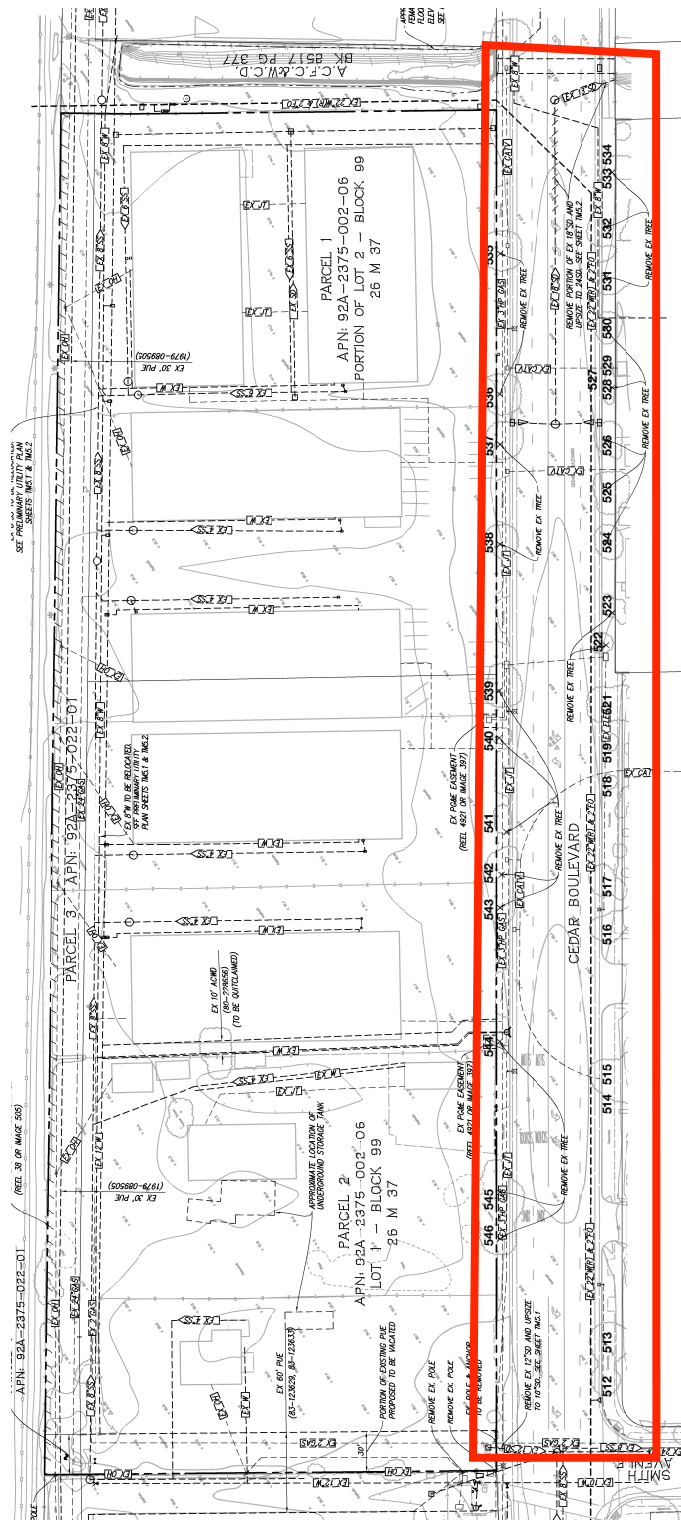
IMAGE 1: TREE LOCATIONS ALONG CEDAR

The "X"s east of the utility pole indicate trees that no longer exist but are shown on the survey.
